DEPARTMENT OF TOXIC SUBSTANCES CONTROL

SUPPLEMENTAL SAMPLING UPDATE
JUNE 27, 2006

CENTEX HOMES
STERLING HOMES DEVELOPMENT

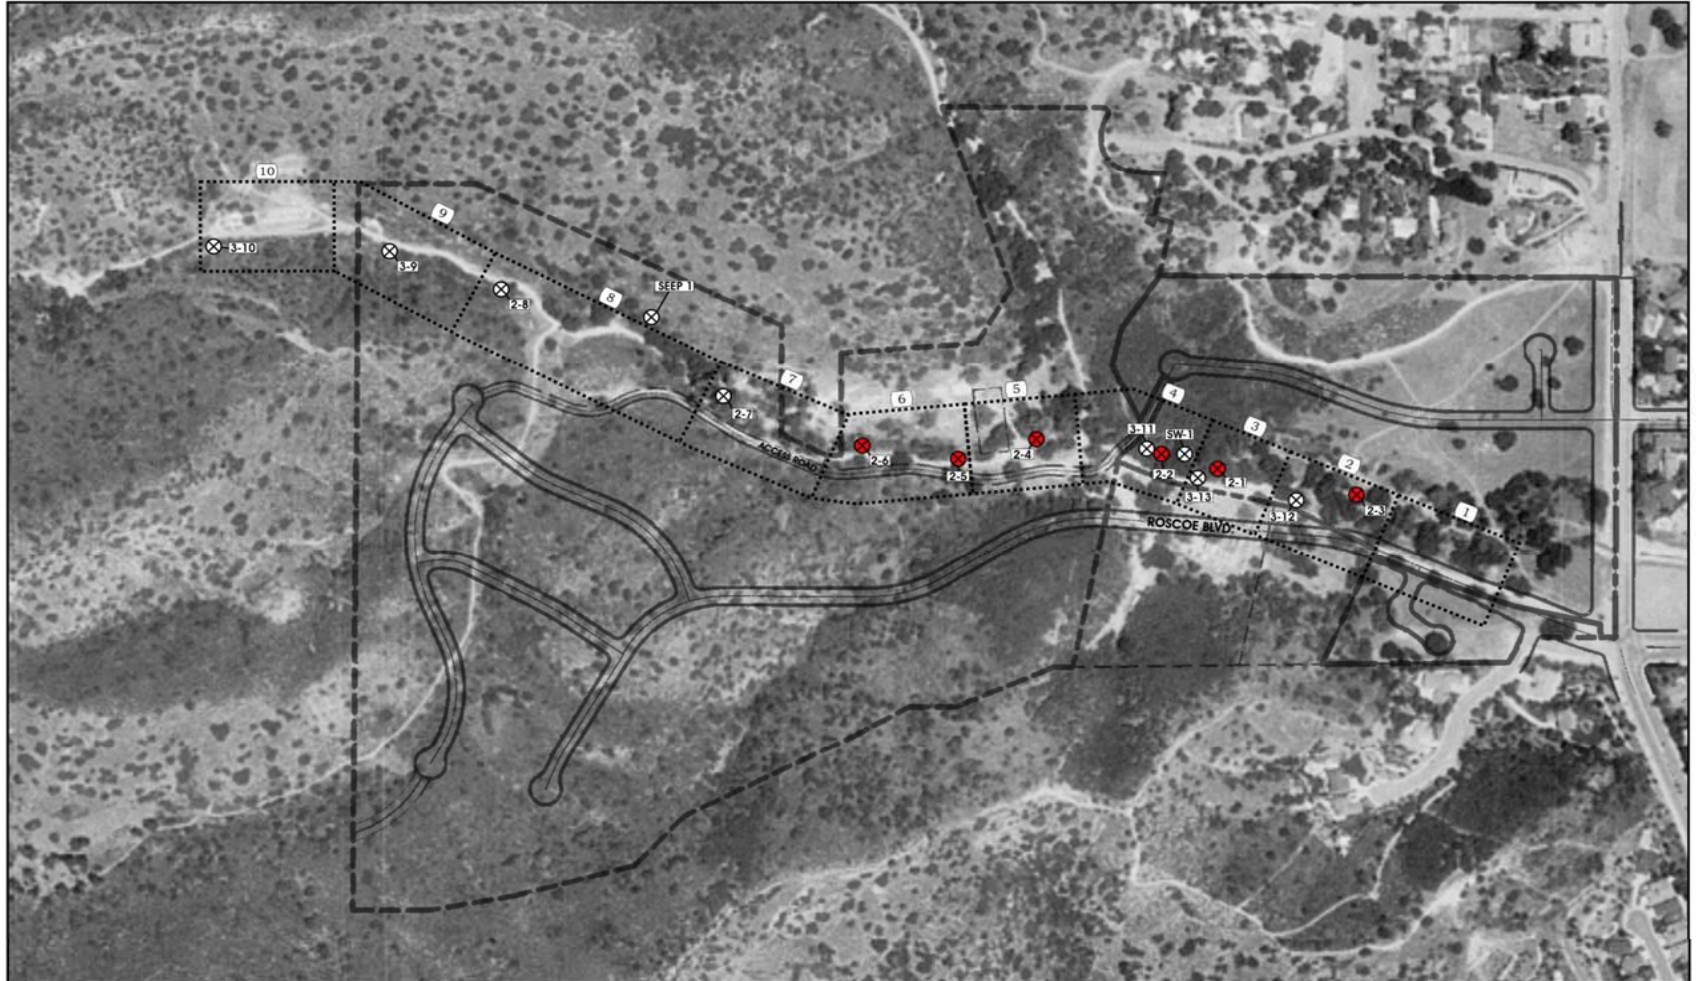
Perchlorate Detections May 2005

- ❑ Perchlorate detected in soil samples collected in May 2005.
- ❑ Centex Homes entered into VCA with DTSC in August 2005.
Scope of the VCA included:
 - a) DTSC oversight of site characterization activities and removal actions for areas of known contamination.
 - b) PEA activities for other areas of the site
- ❑ Soil sampling conducted from September to December 2005.

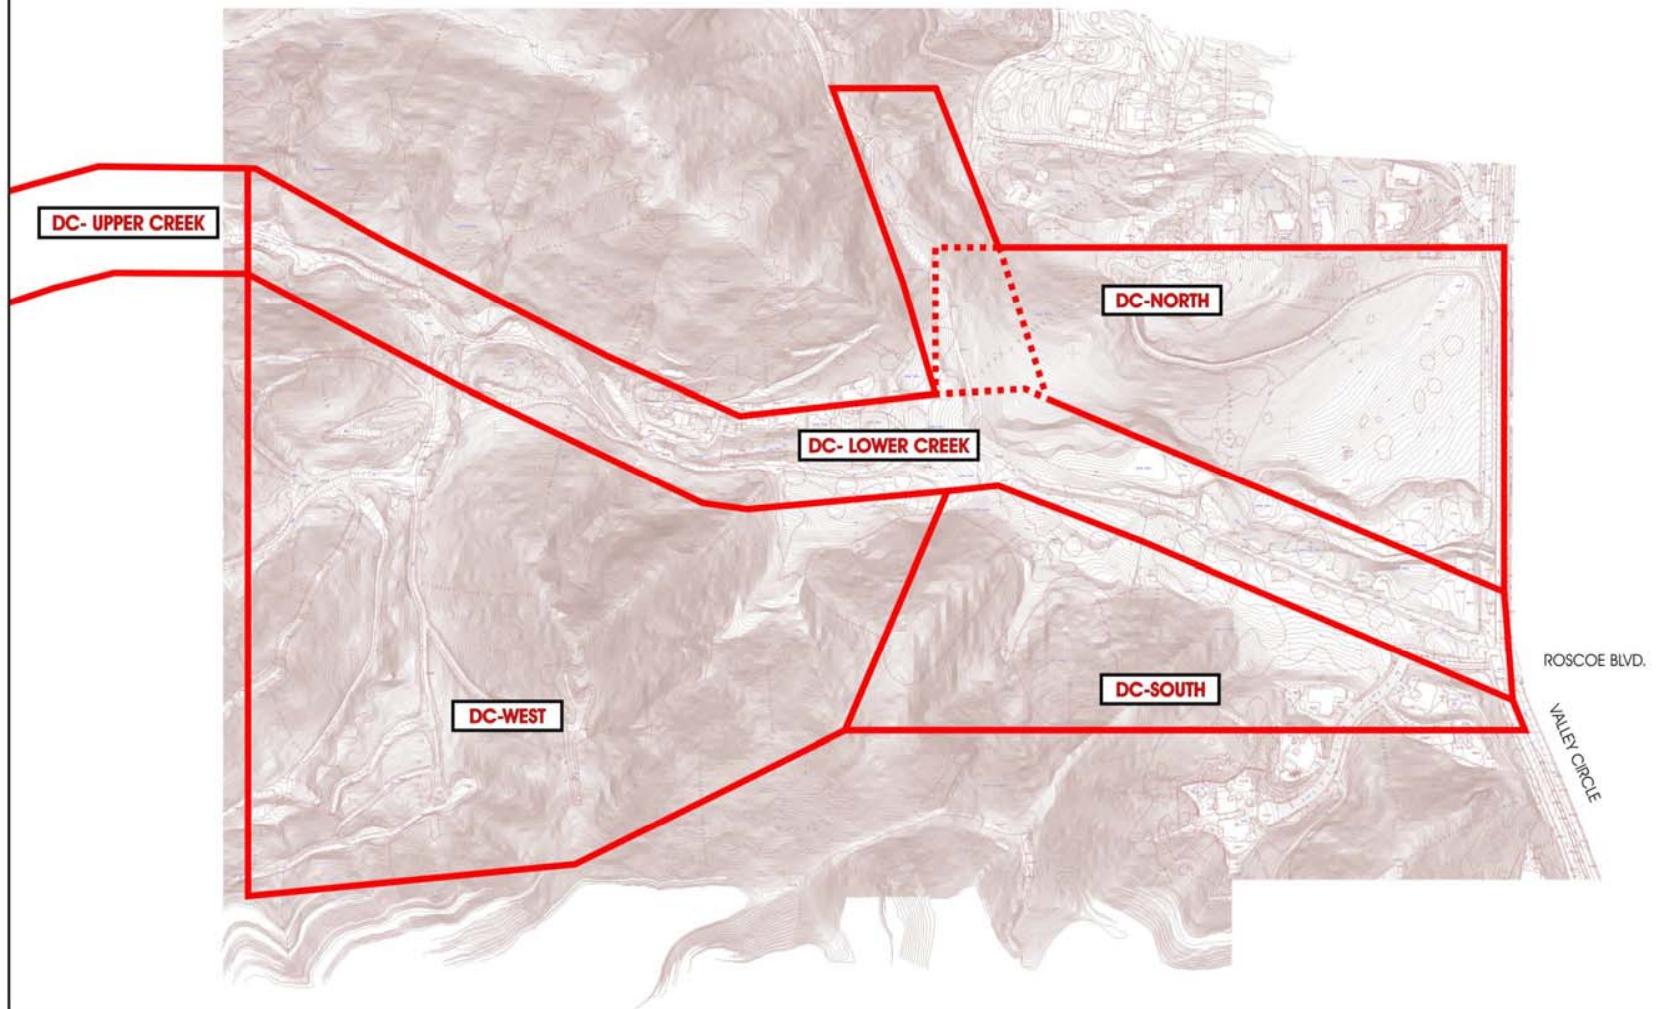
FIGURE NO. 7

DAYTON CANYON SAMPLING AREAS
STERLING HOMES
WEST HILLS, CA

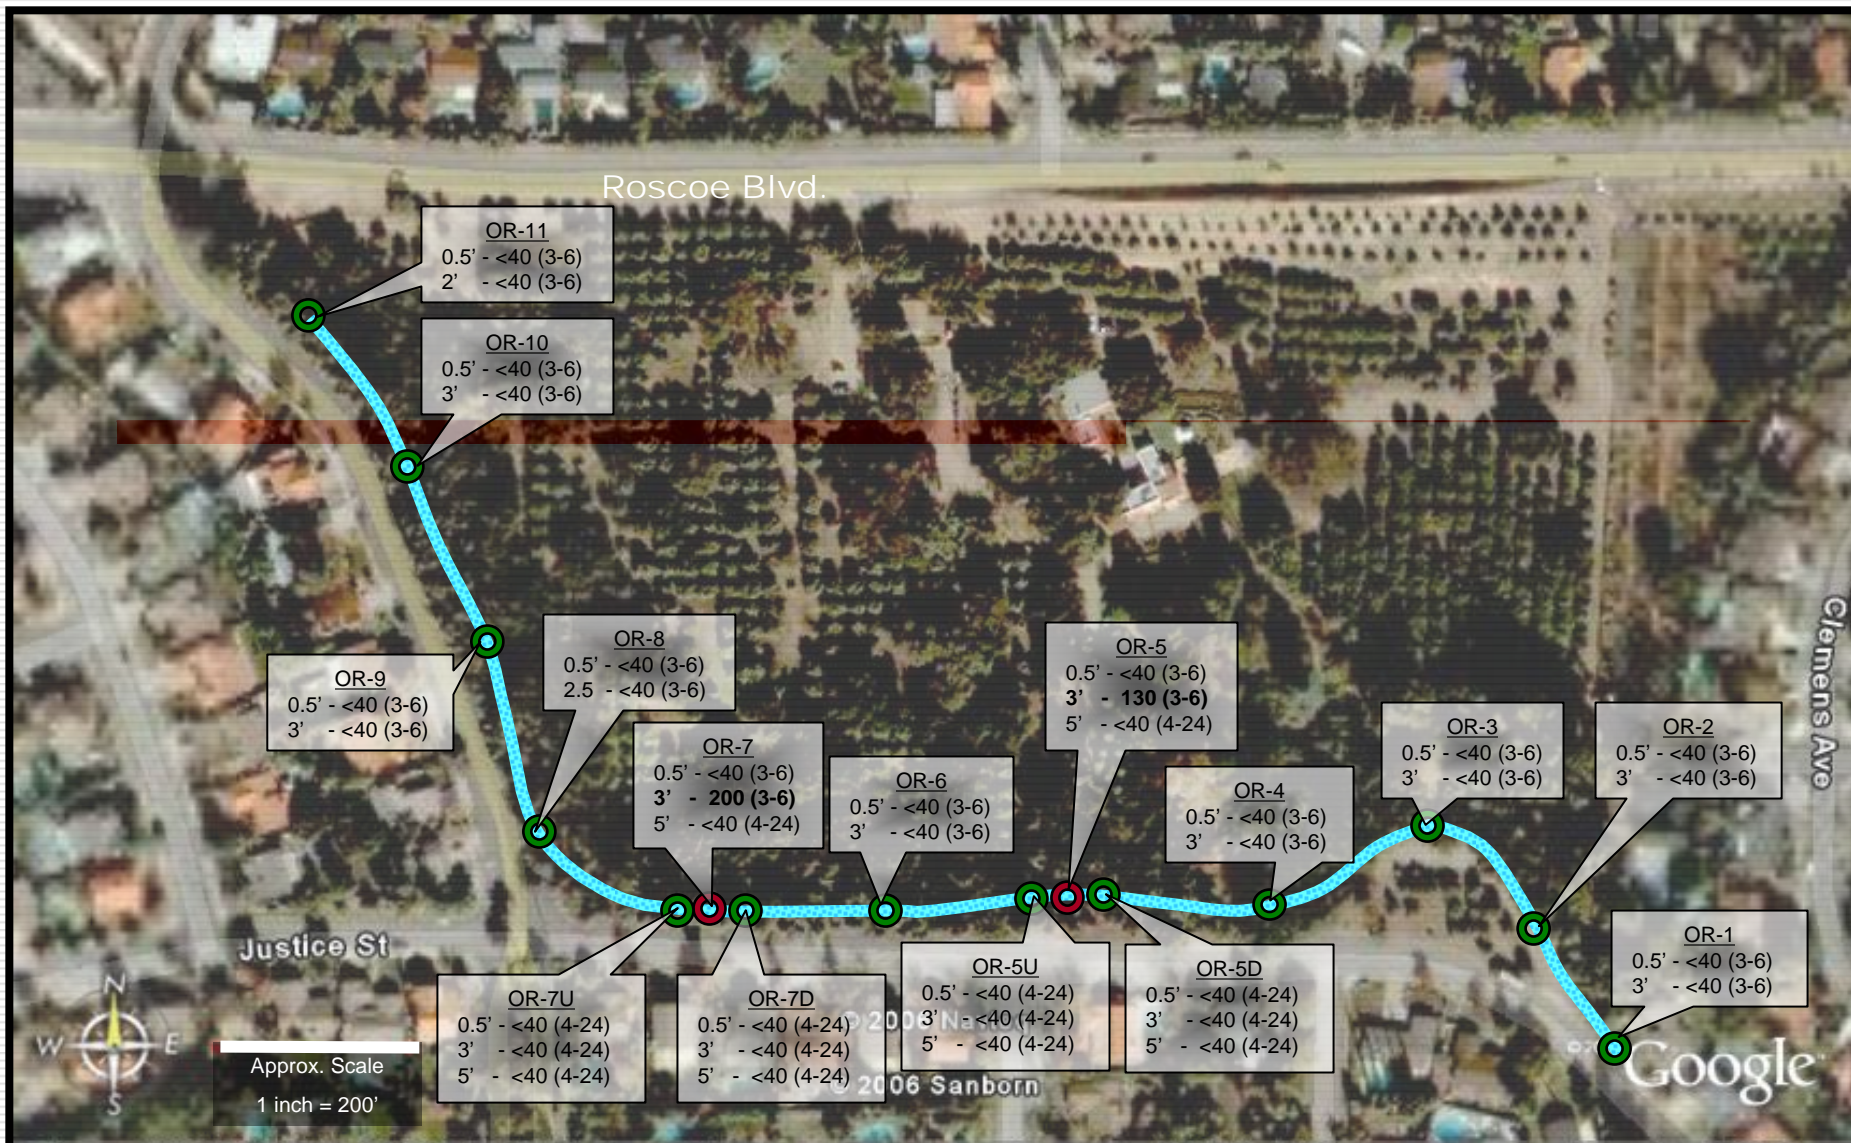
Figure 1
Sampling Locations
Orcutt Ranch Limited Investigation

- ☐ Soil samples collected by DTSC Staff on March 6th and April 24, 2006 at Orcutt Ranch Park.
 - 37 soil samples
- ☐ Soil Sampling at Justice Elementary School on April 10, 2006.
 - 25 soil samples collected from 10 unpaved locations (gardens, tree boxes and grassy areas)
- ☐ Perchlorate was not detected in any of the soil samples.
